ETL 1110-2-533

30 September 1994

**Engineering and Design  
LIFELINE REPORT NO. 1, SYSTEMS AT RISK FROM EARTHQUAKES,  
HYDROELECTRIC POWER PLANT FACILITIES**

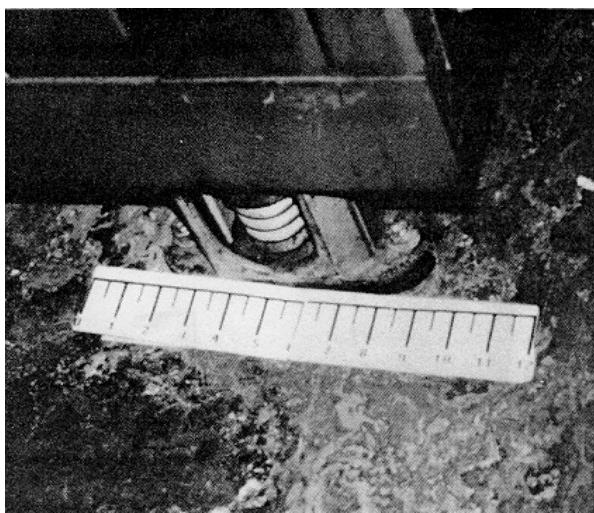
(11) Figure B-7 shows a type of vibration isolator that frequently fails. The members enclosing the spring are made of cast iron, and there are no restraints to limit the motion of the unit if the isolators fail. Failure of the vibration isolators can cause the engine generator to move more than a foot. This may cause the failure of fuel, water, power, and control lines.

**Figure B-7. Vulnerable engine generator vibration isolation system**
